# SLOWIND PROJECT TEWZ115012

## STRUCTURAL HEALTH AND LOAD MONITORING OF WIND TURBINE BLADES

Date	30 January 2019
Author(s)	T.H. (Rob) Jansen & H.L.M. (Haico) van der Heijden (TNO)
Number of pages	14
Project name	SLOWIND
Project reference nr.	TEWZ115012

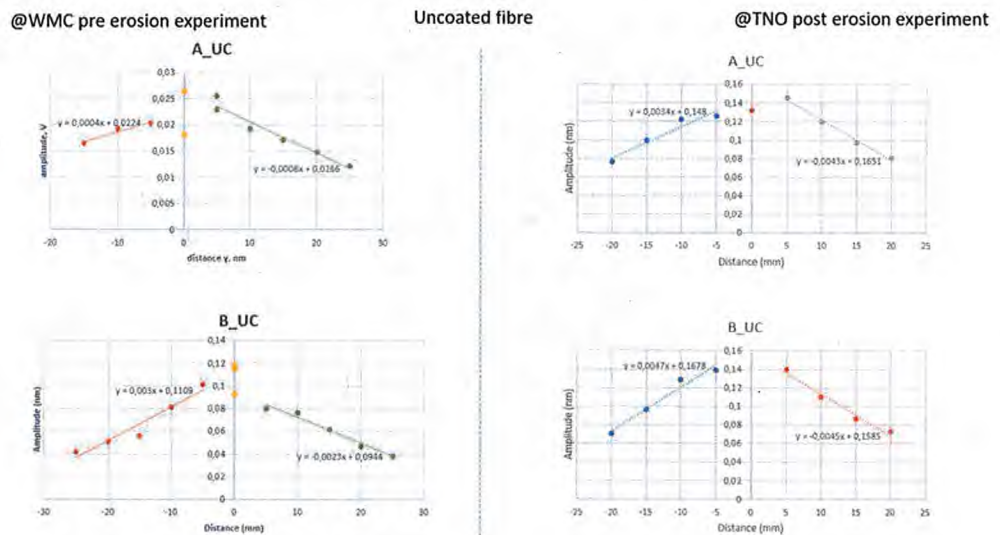
Figure 5. Test result – droplet erosion measurement

- Erosion areas created @ WMC is different compared to erosion of a turbine blade in practice;
- Two different Fibre Bragg Gratings have been applied, coated and non-coated. The Uncoated FBG showed more consistent FBG signal;
- The amplitude depends on the following parameters (height and weight → impact energy) and the distance to the FBG (x position). This has been demonstrated with a steeper slope for higher impact energy shown in Figure 5;
- It can be concluded that it is possible to measure rain droplet erosion with an FBG embedded in the composite, combined with a TNO read-out unit able to sample at high frequencies.

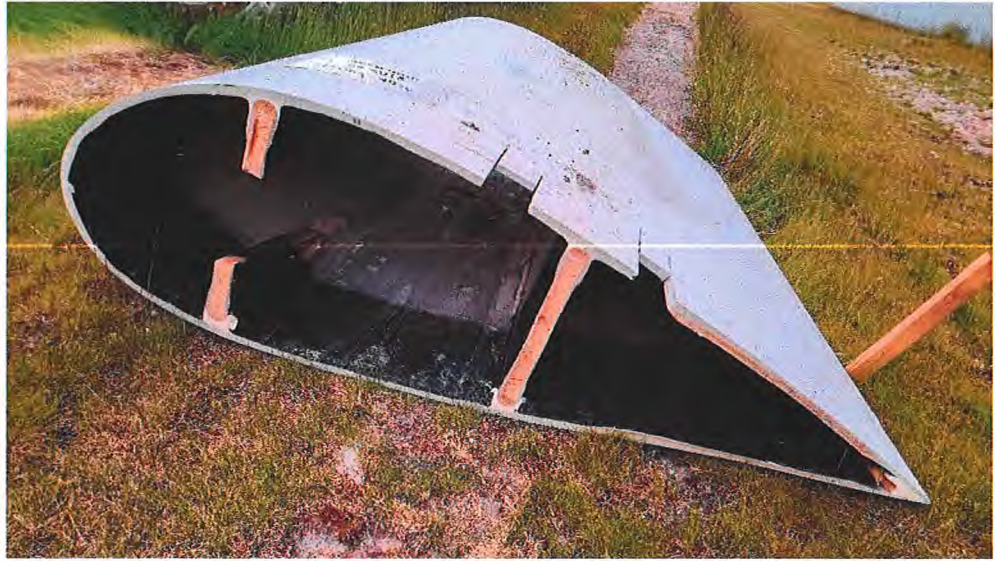
Figure 7. The section of the wind turbine blade.

The sensing and monitoring concepts developed in the previous two WPs will be demonstrated and validated on laboratory scale test set-ups and in full scale set-ups. An example of a section of the turbine blade that has been tested is shown below.

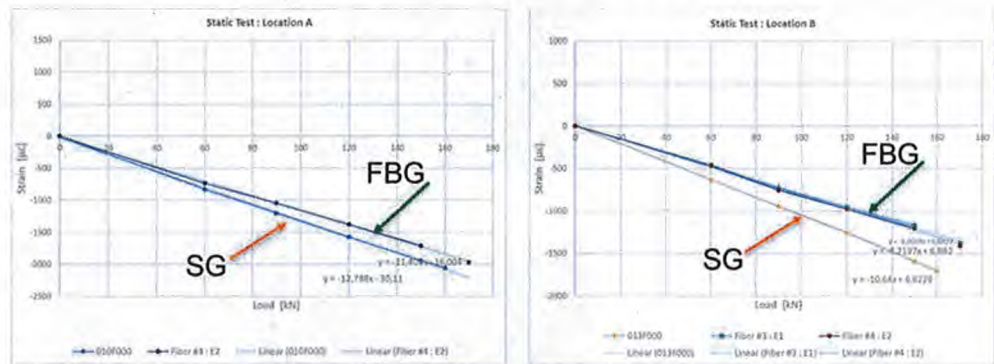
Figure 9. Strain signals of embedded fibre optic Fibre Bragg Grating (FBG) sensors at two locations.

The embedded fibre optic Fibre Bragg Grating (FBG) sensors survived the fatigue & extreme static load experiment up to 170 kN, shown in Figure 9.
